EGYPTIAN CIVIL AVIATION AUTHORITY

REPORT OF INVESTIGATION OF ACCIDENT

EgyptAir Flight 990

Boeing 767-300ER SU-GAP

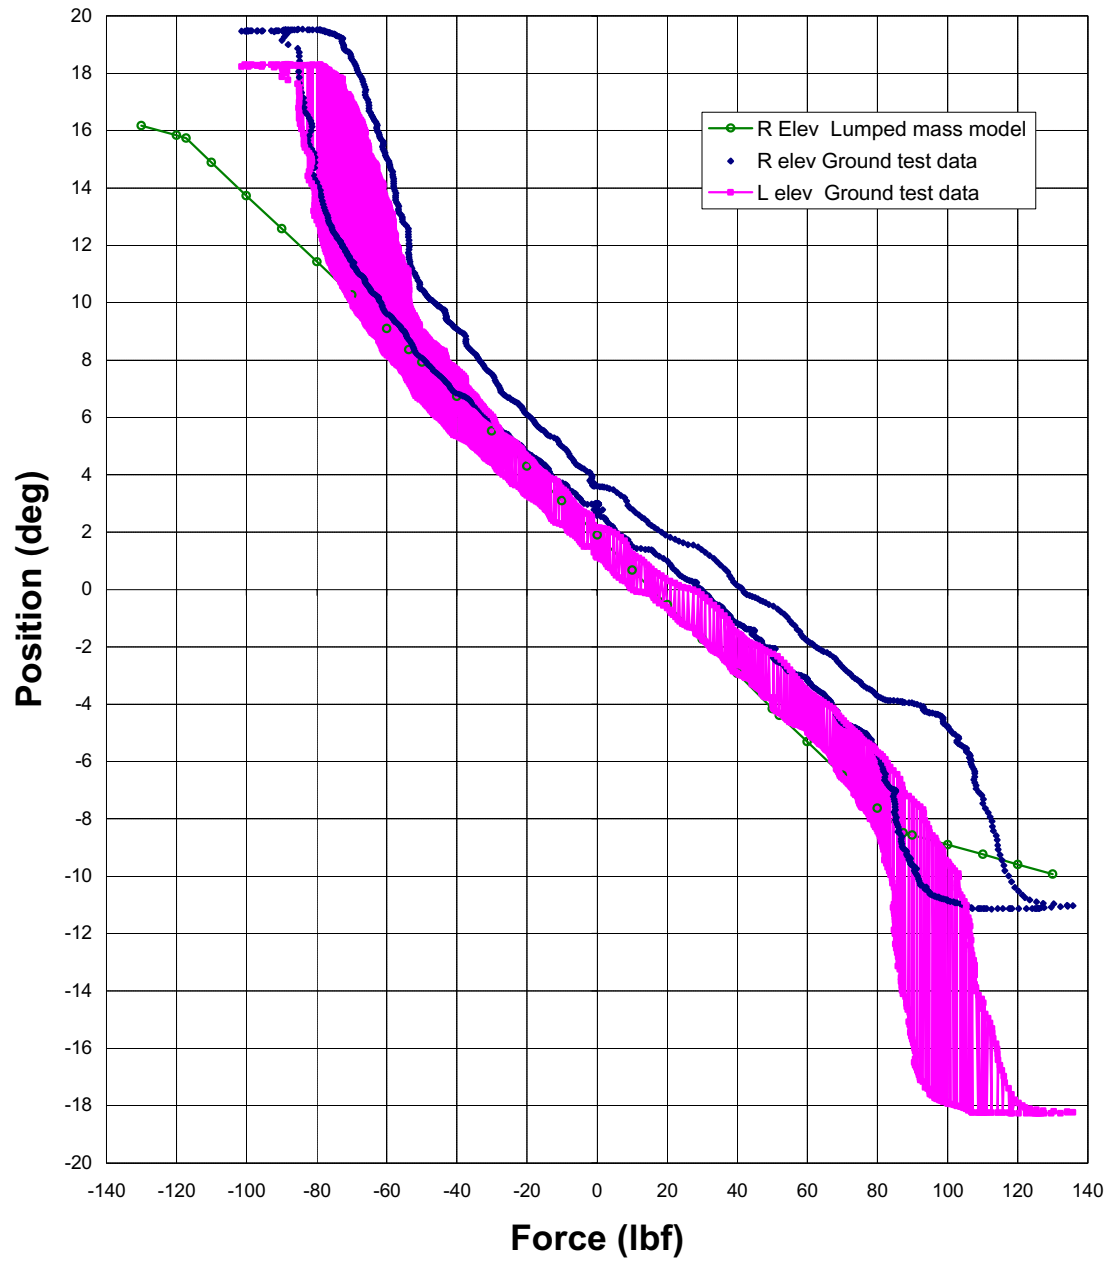
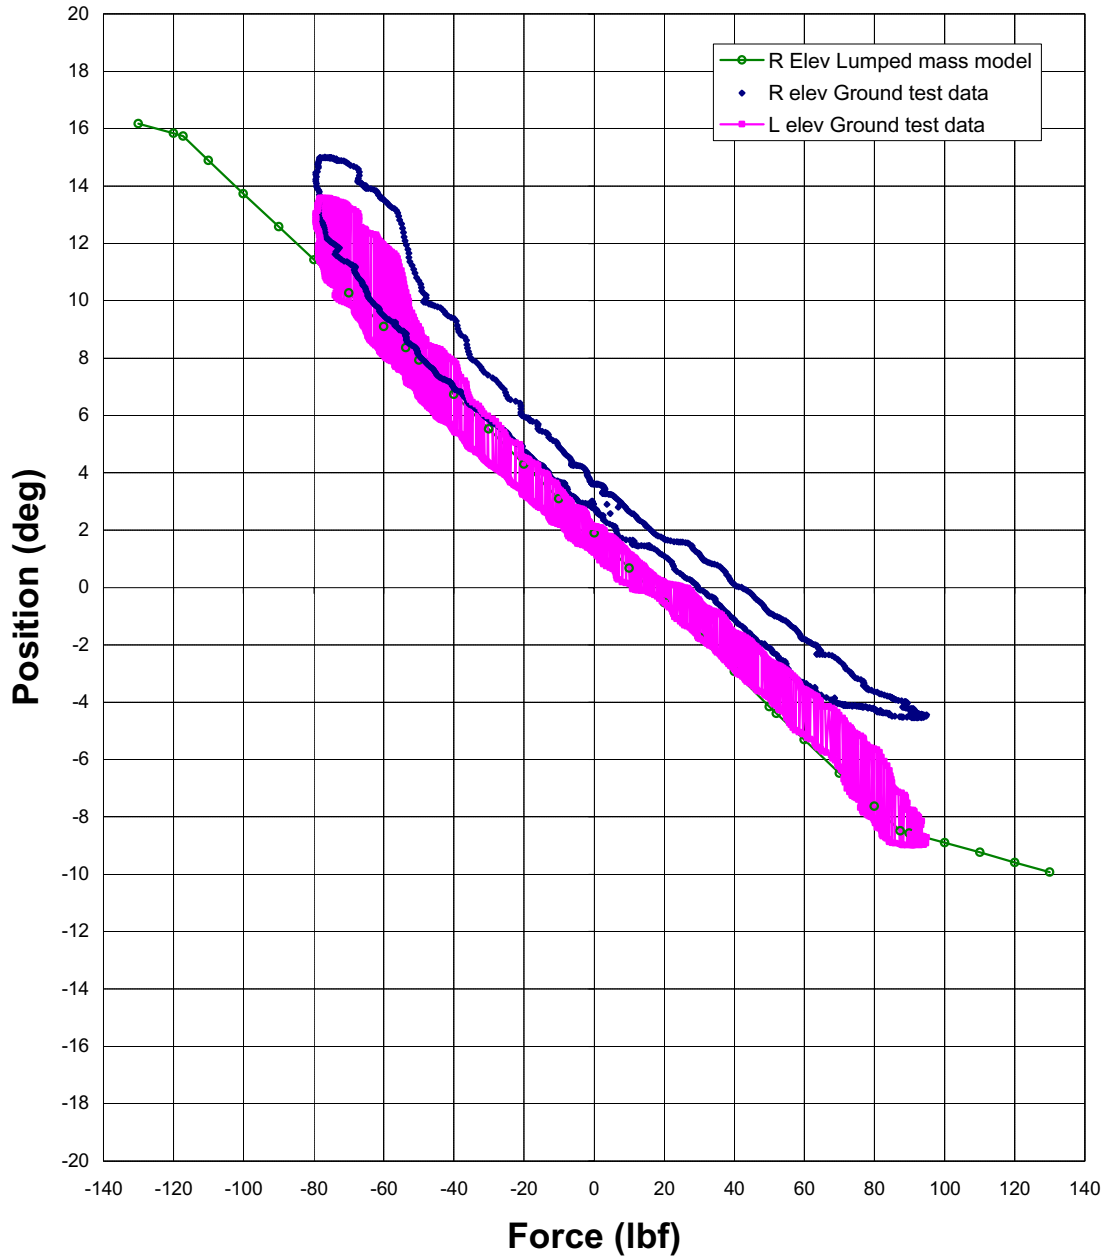
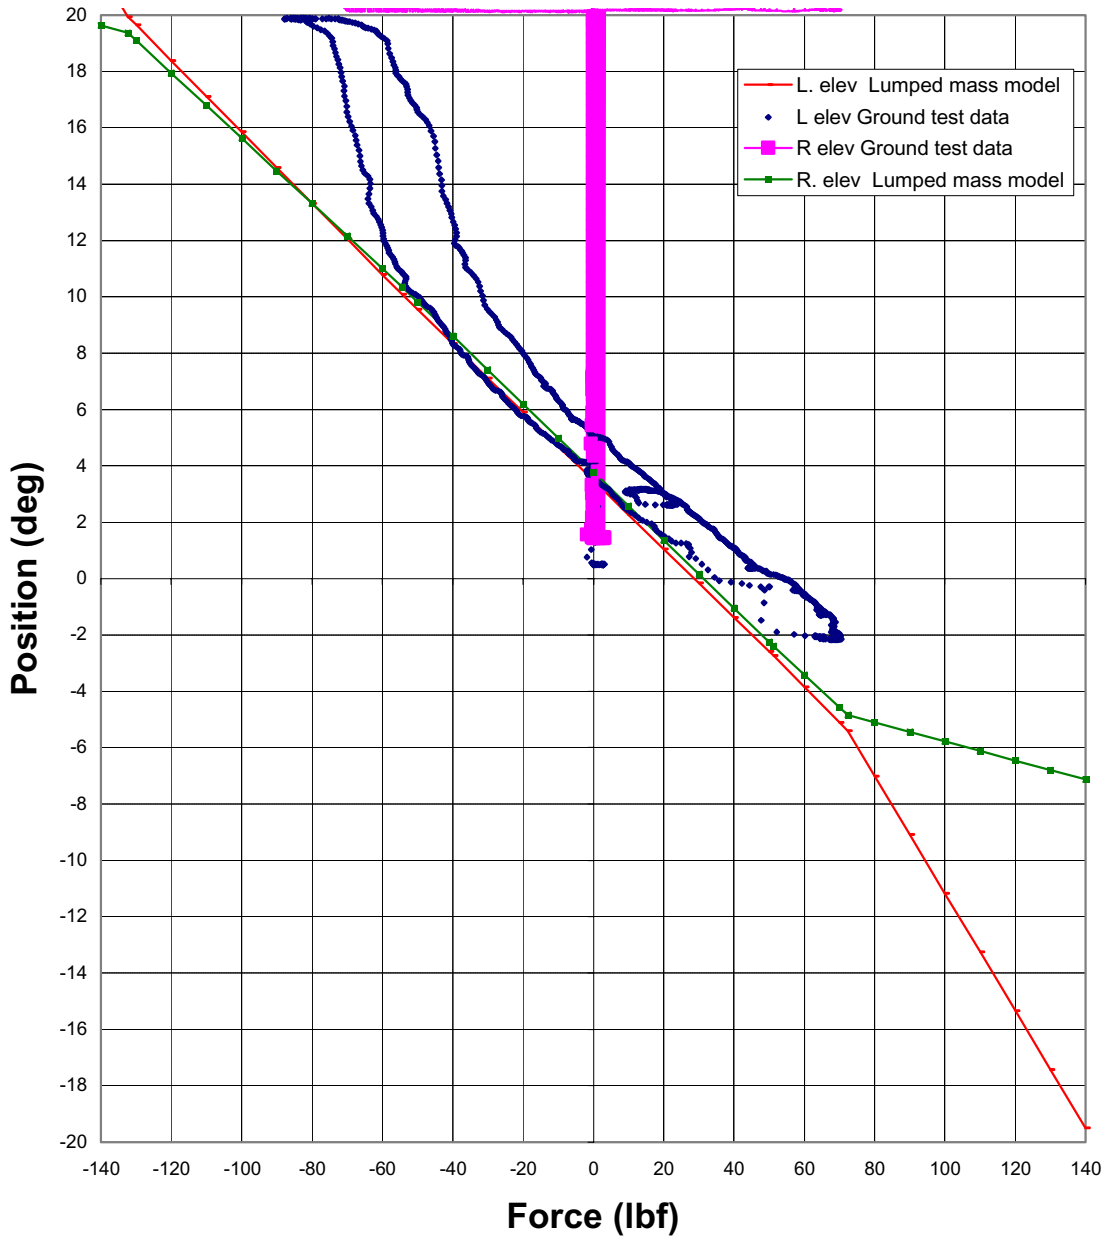
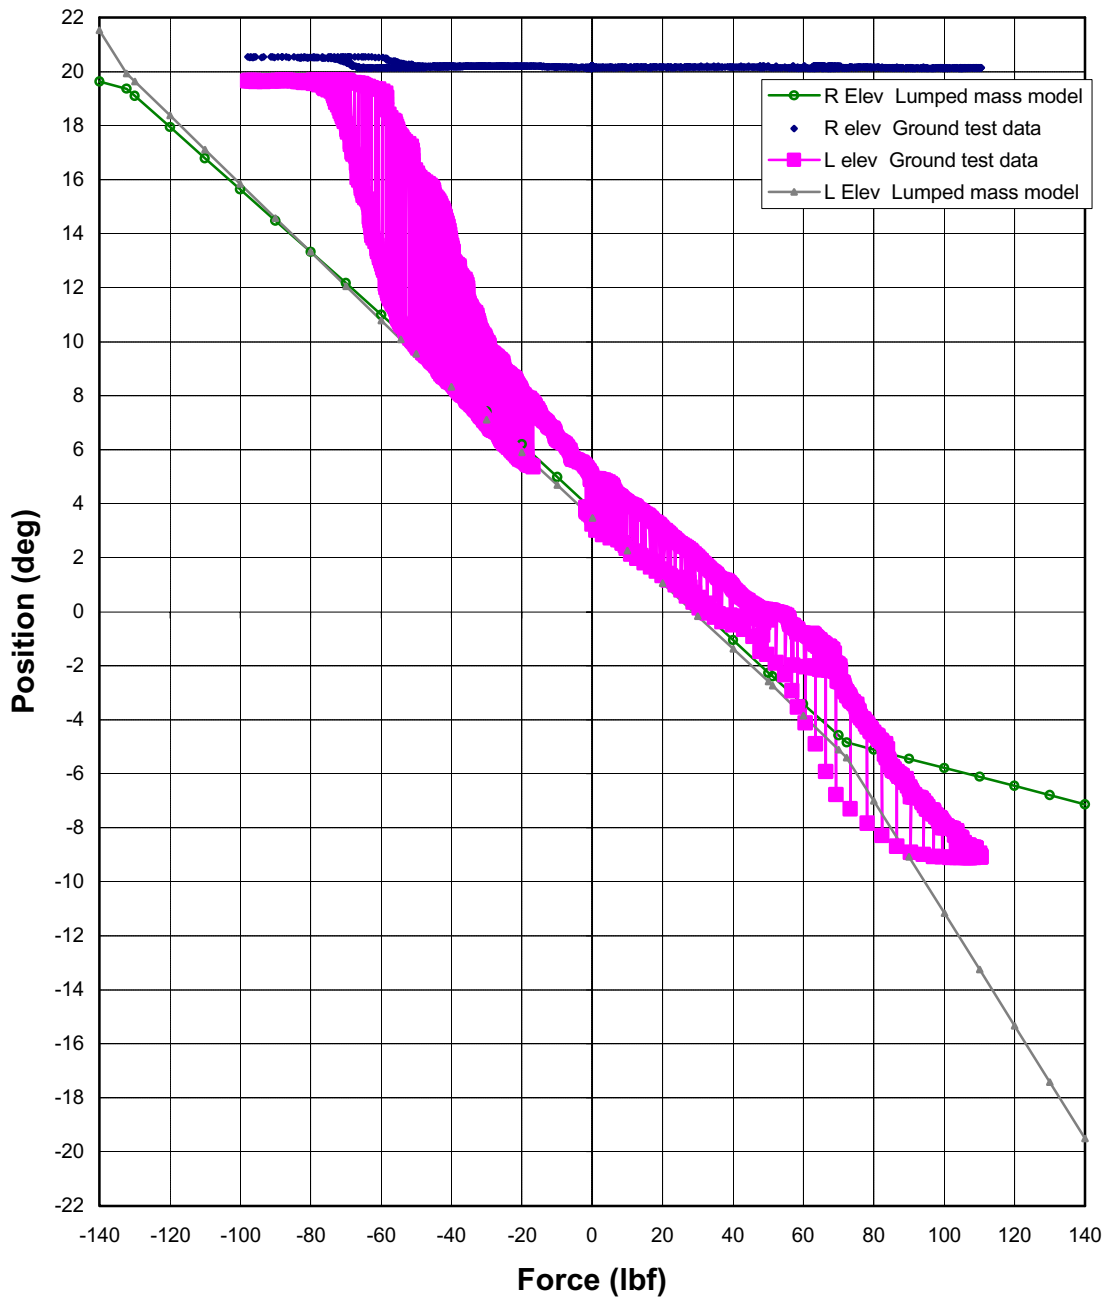
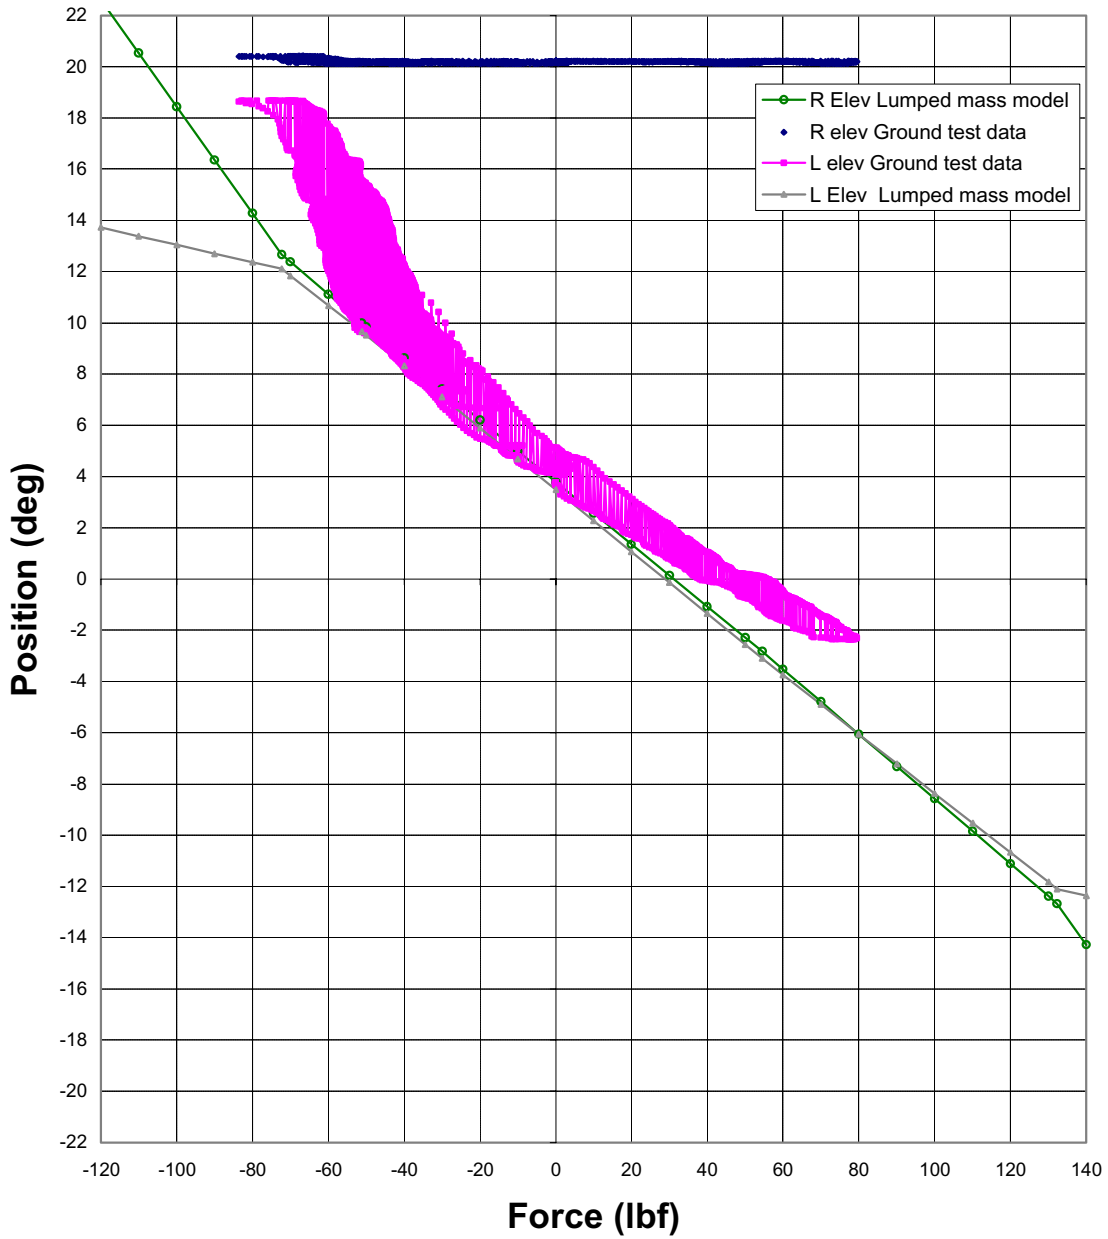
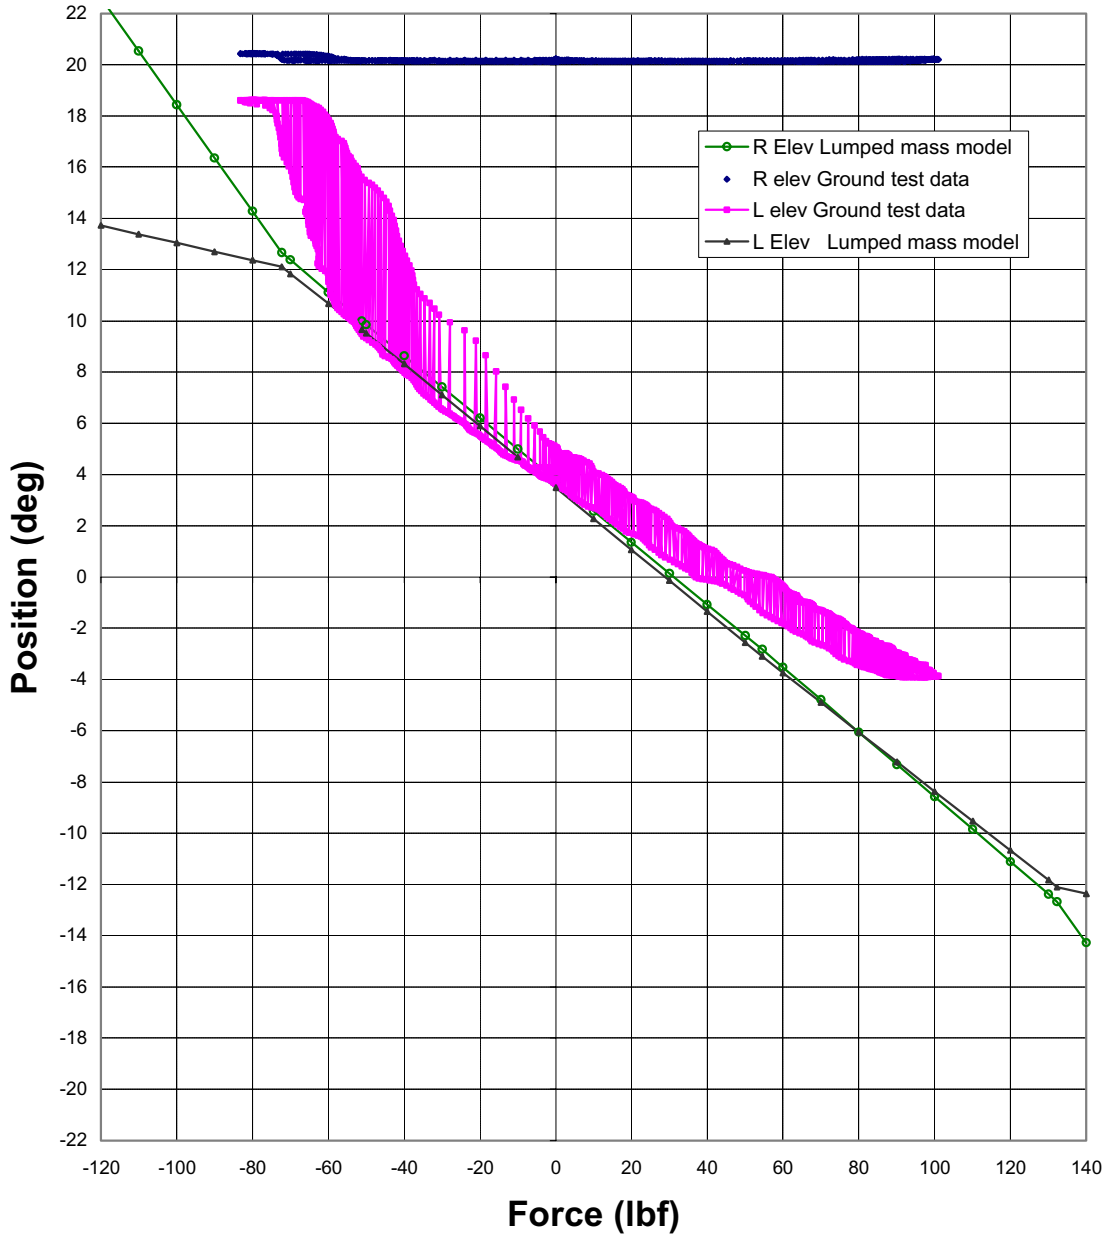
The data gathered during the ground tests conducted on the 767 does not support the Boeing mathematical study regarding single and dual PCA failures. In addition, the data does not correspond with the mathematical description of the elevator control system previously provided by Boeing. See Figures A-3.14 to A-3.17. These Figures present the elevators deflection as obtained from Boeing analytical model and the 767 ground test.

As shown in these figures, the “elevator force – deflection relationship” obtained from the 767 ground test is not consistent with the relationship obtained analytically in Boeing report B-H200-16968-ASI-R2 (Split Elevator Failure Scenario, dated September 29, 2000) and Boeing report B-H200-17026-ASI, (767 Elevator System Operation with Regard to Column Splits, Aft Quadrant Splits, and Column Jams, dated August 2, 2000).

The actual ground test results always show much higher force at the same elevator deflection compared with Boeing analytical results on which Boeing based most of its conclusions.

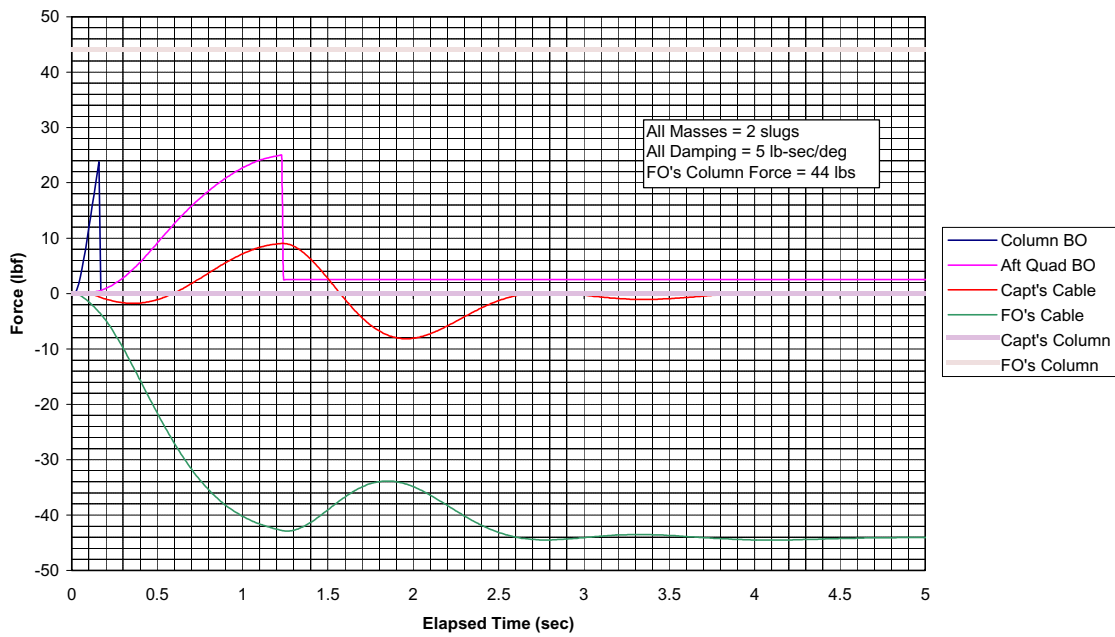
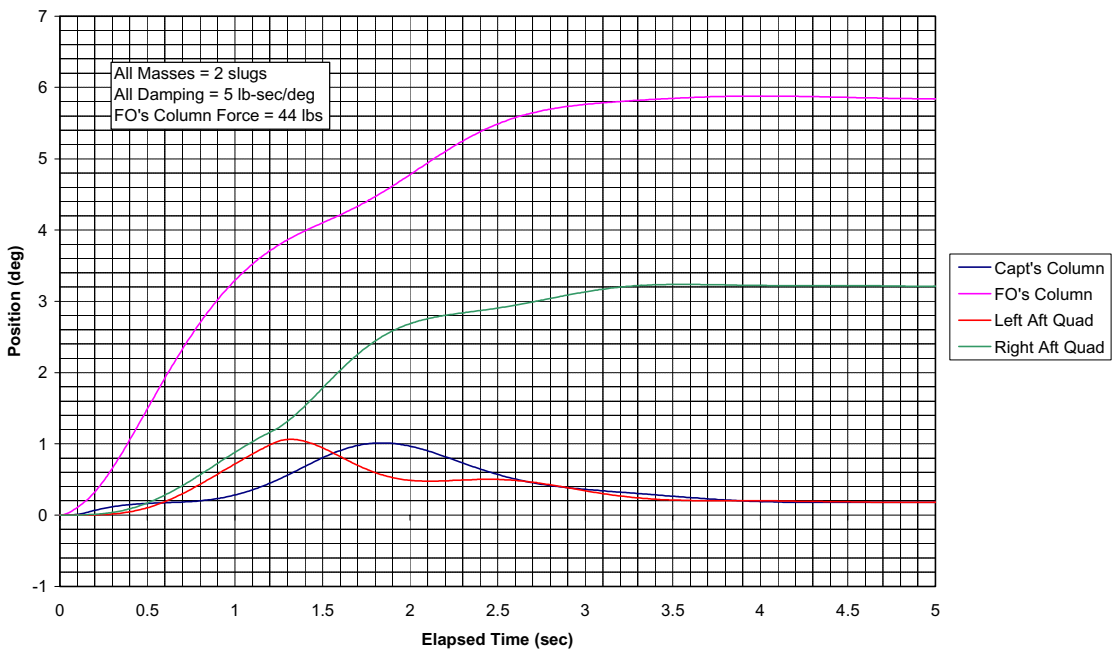
Figure A-5.6. Elevator Control System Forces with Right Column Force of 44 lbf.

This analysis shows that elevator splits can occur. Figures A-5.6 and A-5.7 show a split, but they do not represent the conditions that existed during the accident because there are no malfunctioning PCAs modeled. In the accident, there were additional forces acting on M_4 from the malfunctioning PCAs. The results shown above simply confirm that an elevator split can occur if sufficient force is applied at one control column and the other is left unattended. This result is contrary to results of the static analysis performed by Boeing. It also provides an explanation for why, with the left seat vacant, the first officer could not control the A/C.

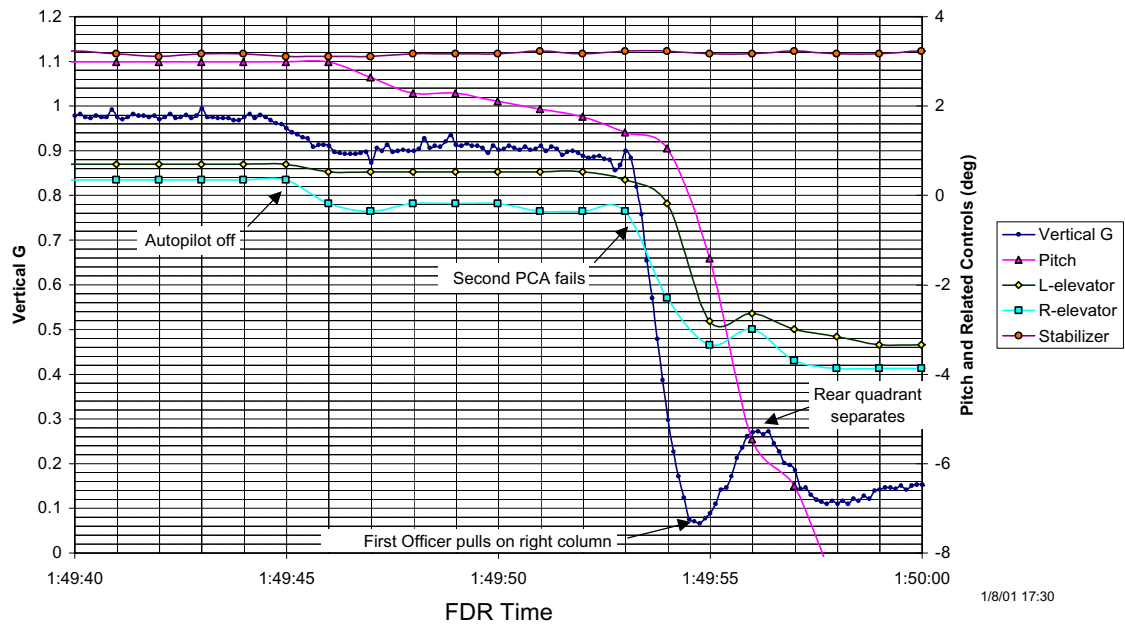
Figure A-5.10. FDR Data Showing Rear Quadrant Breakout.

There is evidence of this failure recorded on the FDR as shown in Figure A-5.10. This figure shows the pitch, vertical load factor, and elevator positions during time around the departure from 33,000 feet. Notice that at 1:49:45, the autopilot turns off, and the right elevator immediately moves approximately 0.6 degrees trailing edge down and the left elevator moves approximately 0.2 degrees trailing edge down. This is a clear indication of one PCA failing and the other two on the right side compensating for the

failure. Approximately 8 seconds later, a second PCA on the right elevator fails and the one remaining PCA cannot compensate, so the airplane begins a nose down pitch. At this time, there is no one in the left seat. The vertical load factor decreases dramatically, and the first officer is initially unable to reach the controls. Approximately 1.5 seconds after the pitchover begins, the first officer pulls back on the control column. The front override separates almost immediately but, because of the dynamic behavior of the elevator control system, the rear quadrant override separates later.

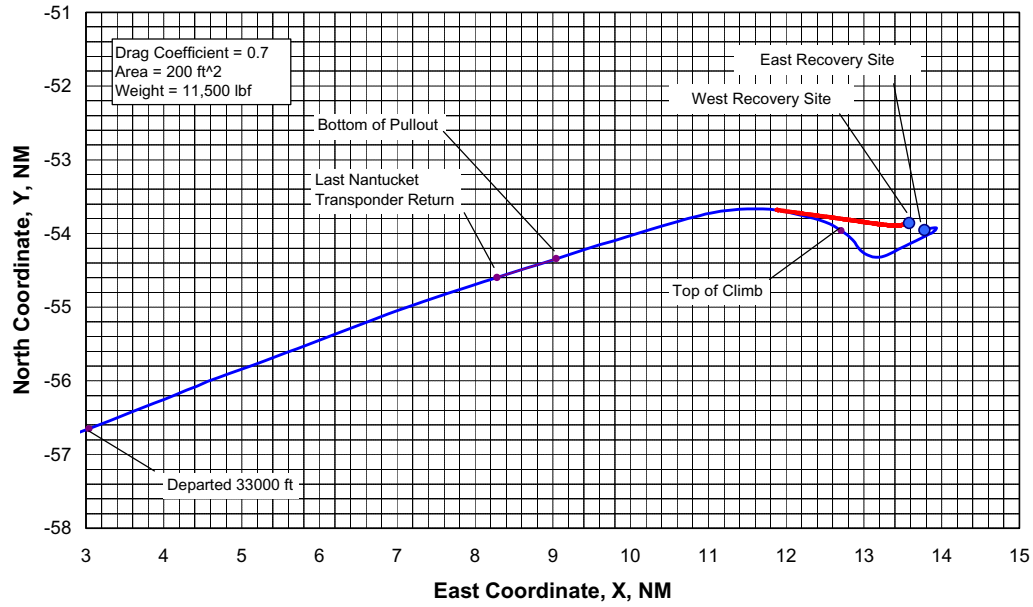
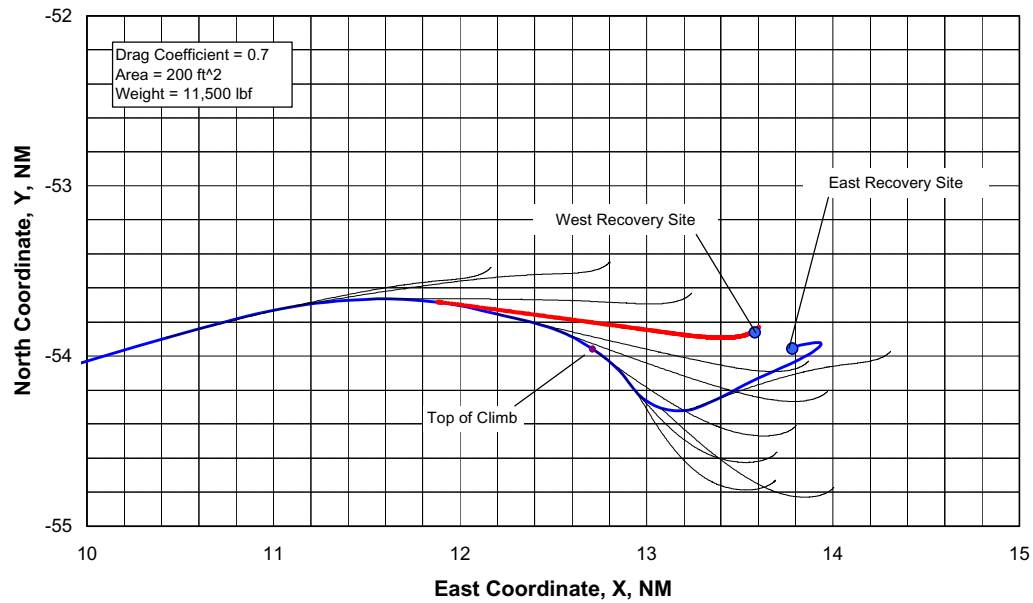
Figure A-6.1. Trajectory Analysis for Left Engine.

Analysis of the recovered left engine mount showed that the engine separated from the airplane by rotating to the left and down. Just before the separation, the airplane was traveling at a speed approaching the speed of sound and experiencing a load factor in excess of 2.5. Because of a lack of experimental data at those speeds, the forces acting on the engine mounts under those conditions have not been calculated, but they are certainly well beyond normal operating conditions.

When the engine separated from the airplane, two important things happened. First, the drag on the left side suddenly decreased significantly. Second, at least one hydraulic system became completely disabled. The sudden decrease in drag surely caused a large yawing moment to the right. Because of the swept wings, this yaw resulted in a large rolling moment to the right. The resulting right bank is reflected in the right turn in the flight path that is shown following the separation of the engine.³⁸

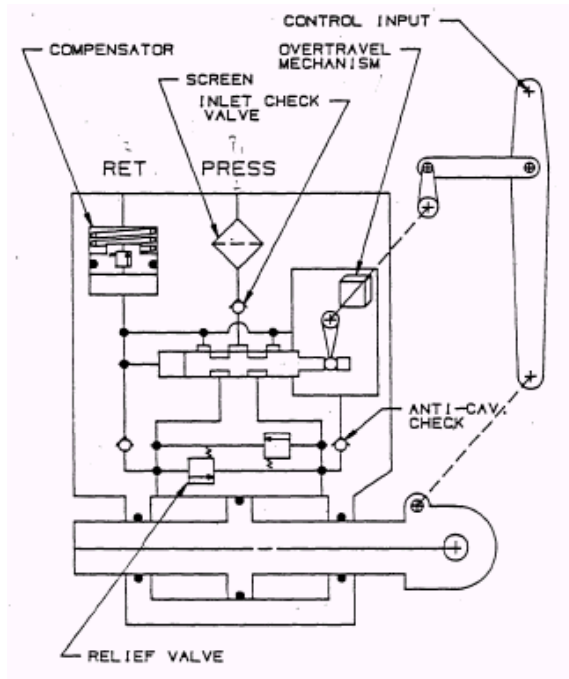
Figure A-7.1 Elevator Hydraulic System

In March 2001, NTSB informed the Egyptian Investigation Team that it has recently discovered some errors in modeling the PCU dynamics during blowdown and blowback situations. The NTSB requested that Boeing develop a revised model and re-evaluate the effects of the failure in the simulator. The NTSB stated that an “omission” in the model was identified that resulted in incorrect calculations of the position of the failed elevator. The missing elements in the PCU model are the relief valves shown in the PCU schematic in Figure A-7.1

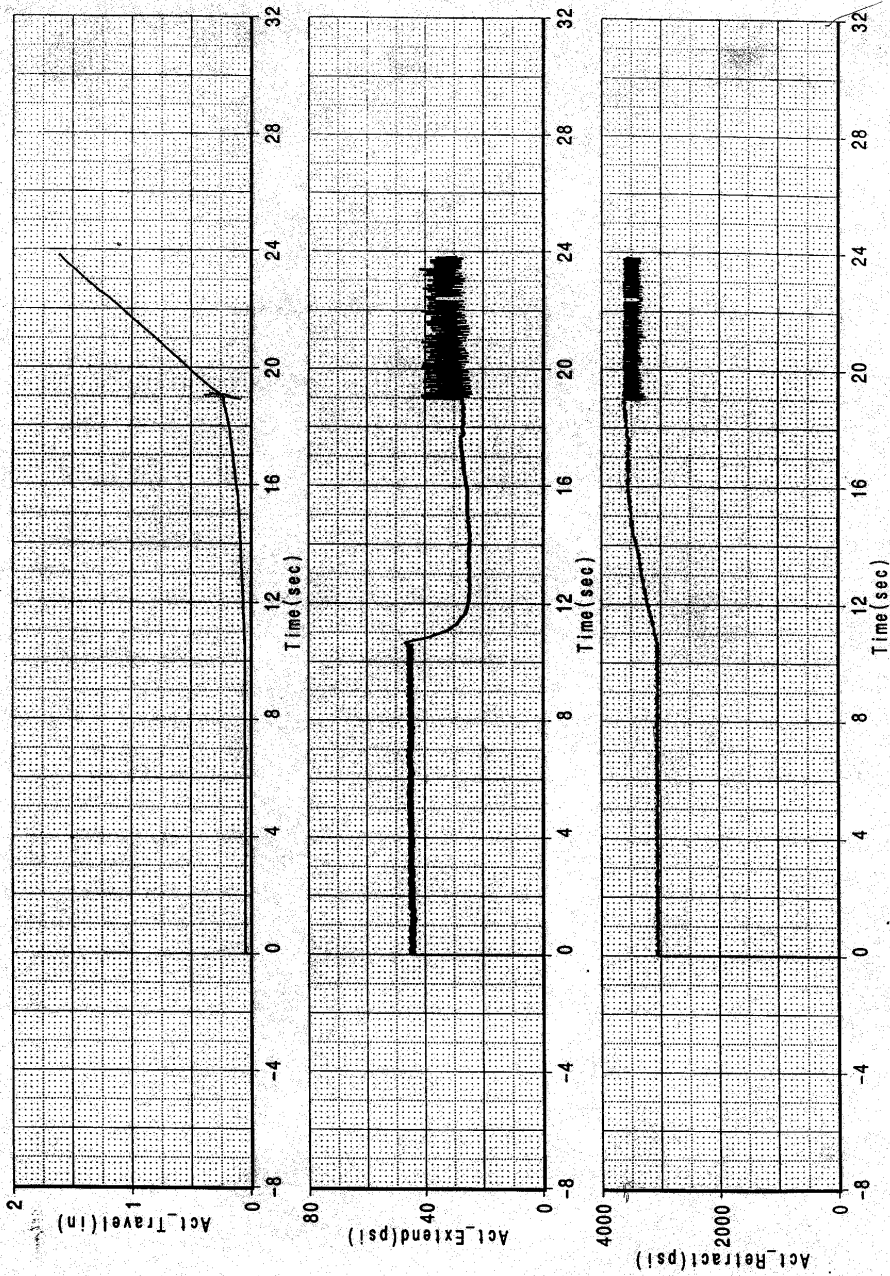
- The effect of internal leakage at other hydraulic elements such as the inlet check valve has been ignored.
 - Figure 16 in Boeing report (Figure A-7.2) shows that during the lab test, the PCA started retraction with increasing retraction pressure before opening of the PCA relief valve (about 0.2 inch) in contrary with Boeing assumptions.
